Collapsed Thoracic Stent Graft After Traumatic Aortic Rupture

We describe the endovascular repair of an aortic rupture with a 28 × 150 mm Gore TAG endoprosthesis (W.L. Gore and Associates, Flagstaff, Ariz, USA) in a 24 mm aorta of a 57-year-old man. On postoperative day 43 a complete aortic obstruction, caused by the collapse of the stent grafts lumen, was diagnosed. Restoration of blood flow was attempted by balloon moulding. After the initially successful balloon dilatation a recollapse of the stent graft was seen in the transesophageal echocardiography (**Figures 1-3 and videos 1-3**). The recollapse was then managed with a second stent graft. No further adverse event was seen in the postoperative course.

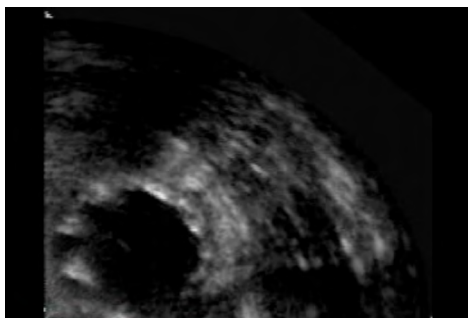
Figure 1 The transesophageal echocardiography shows the complete expansion of the stent graft, but a slight compression during the systole.

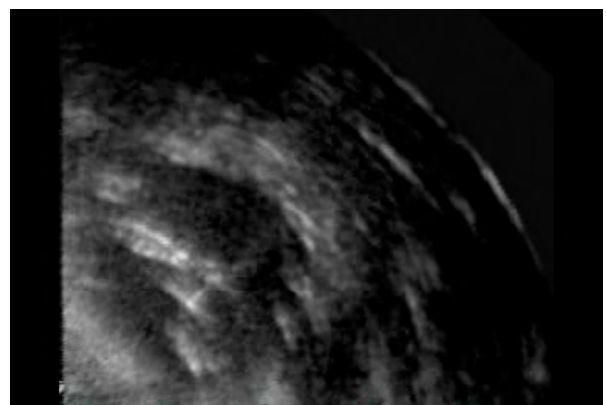
Figure 2 The picture shows the collapse of half of the stent grafts diameter.

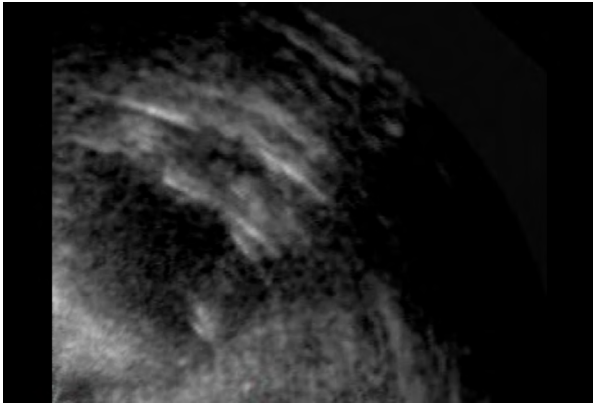
Figure 3 Finally the stent graft is completely compressed..

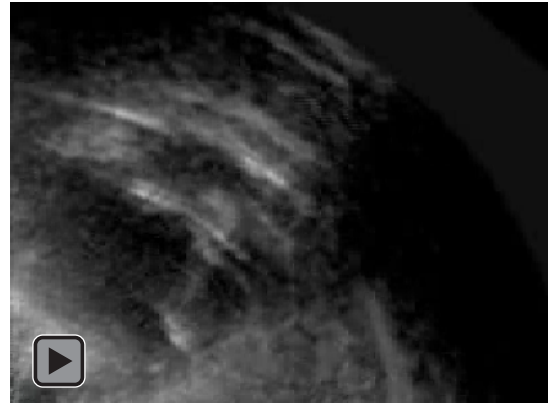
Video 3 Finally the stent grafts lumen is completely collapsed with the following occlusion of the aorta.

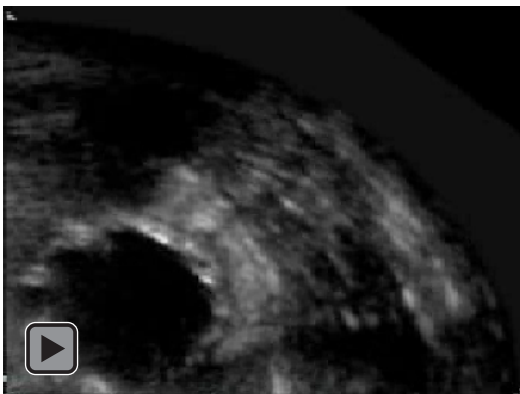
Video 1 After balloon moulding the stent graft is re-expanded, but shows a pulse synchronic compression of the lumen.

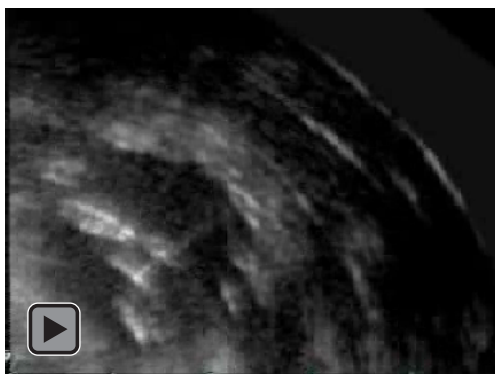
Video 2 Only a few seconds later the stent graft undergoes a re-collapse with the compression of nearly half of the diameter.
